Case 371 : Narrative

Case Vehicle (A): 2002 Ford	Vehicle (B): 1988 Chevrolet
Type: Explorer Sport, 4 x 4, 2-door SUV	Type: C1500, 2-door, 4 x 2 pickup
Driver: 26-year-old male	Driver: 67-year-old male
CDC: 11-FYEW-2	CDC: 99-0000-0

CASE NO.: 371-03

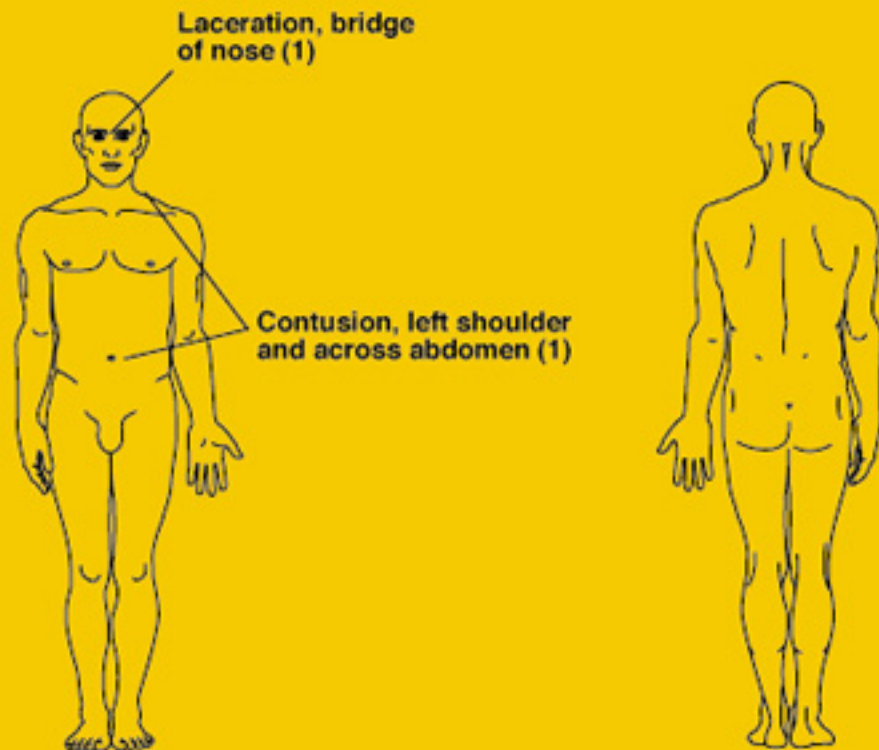
On impact, the driver moved forward and to the left relative to the vehicle interior. He sustained a laceration to the bridge of the nose, probably due to contact by the deploying airbag. He sustained contusions to the left shoulder and across the abdomen, probably due to loading by the shoulder and lap belts.

The following table and attached drawing [59](#) summarize the injuries for the driver of case vehicle (A).

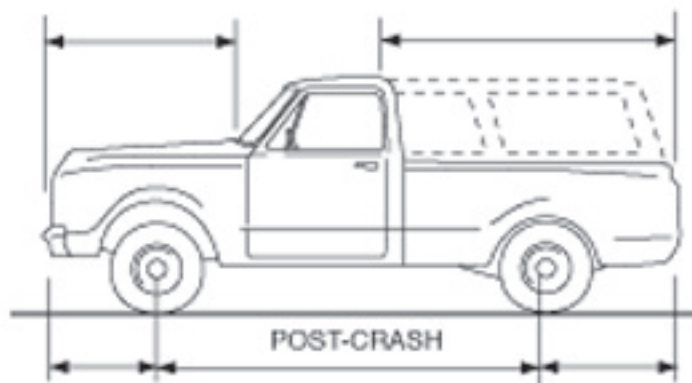
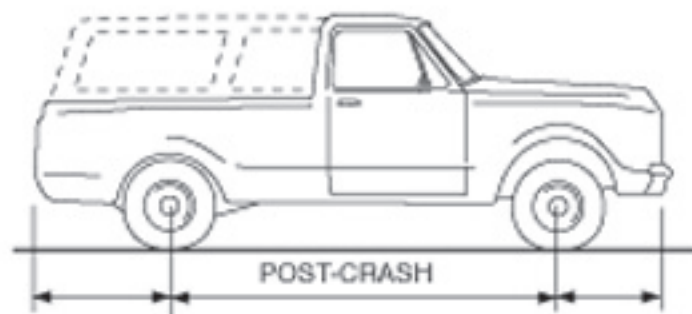
7 Damage to case vehicle (A) was moderate. 8 Direct damage began at the left-front bumper corner and extended 92-cm to the right, resulting in 60-percent vehicle overlap (VOL). 9 The maximum crush was 34 cm and occurred at the left-front bumper corner. Vehicle (B) was unavailable for inspection.

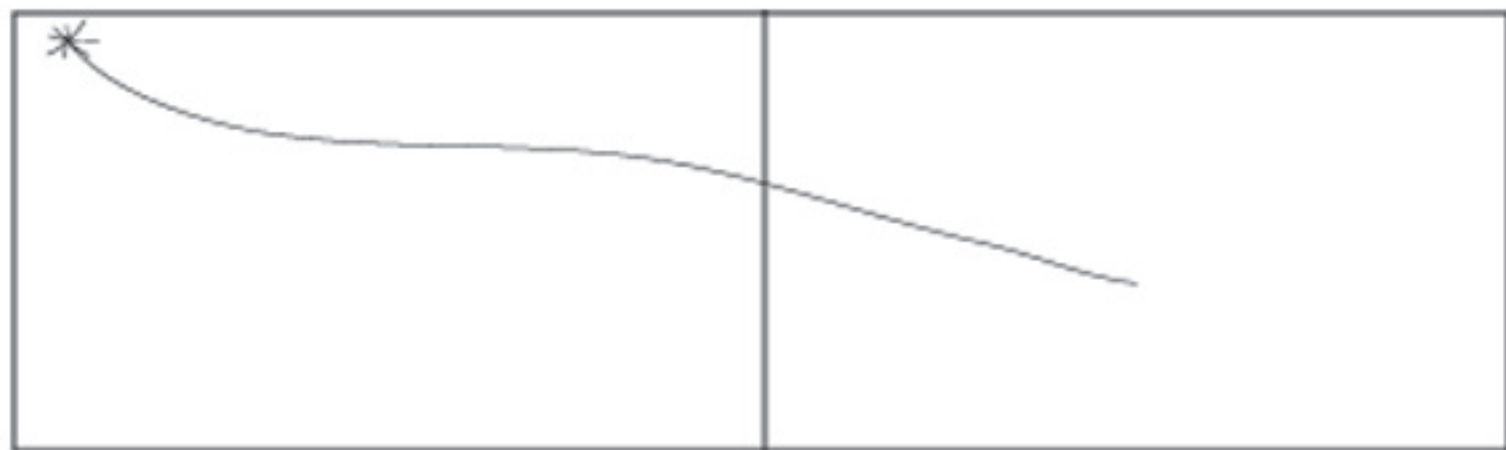
WINDSHIELD MARK ON CASE VEHICLE:

Windshield cracked on left due to contact by an exterior object

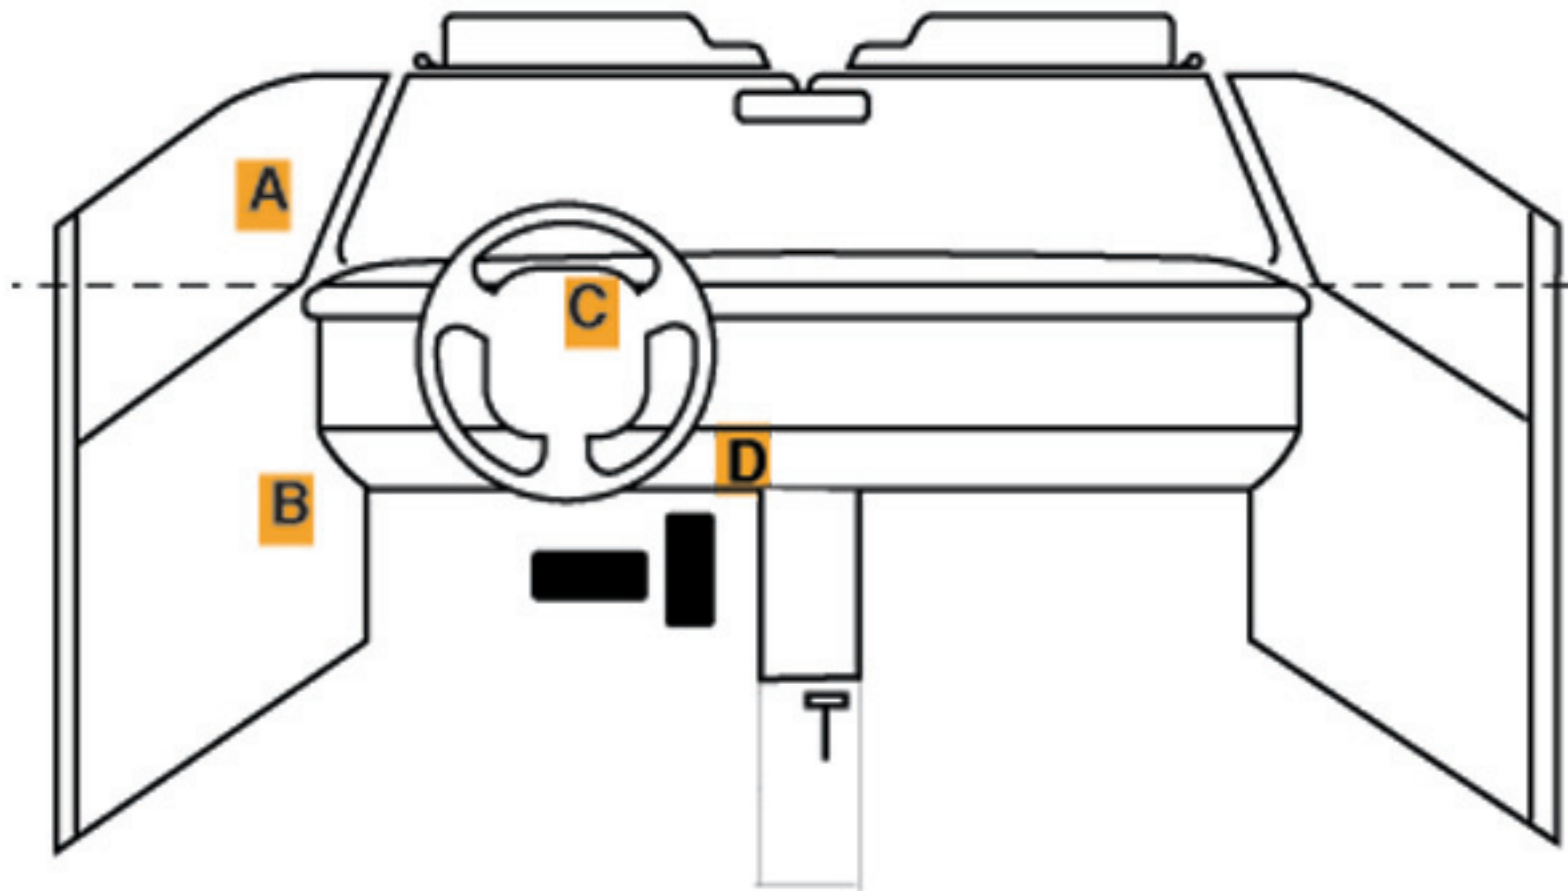
OCCUPANT CONTACT WORKSHEET

A = driver door window, blood deposit

B = driver door panel, hardware and armrest, cloth patterned scuffmark

D= knee bolster, scuffmark
